INDOOR AIR QUALITY ASSESSMENT

**Holliston High School
370 Hollis Street
Holliston, Massachusetts**

Prepared by:
Massachusetts Department of Public Health
Bureau of Environmental Health Assessment
March, 2001

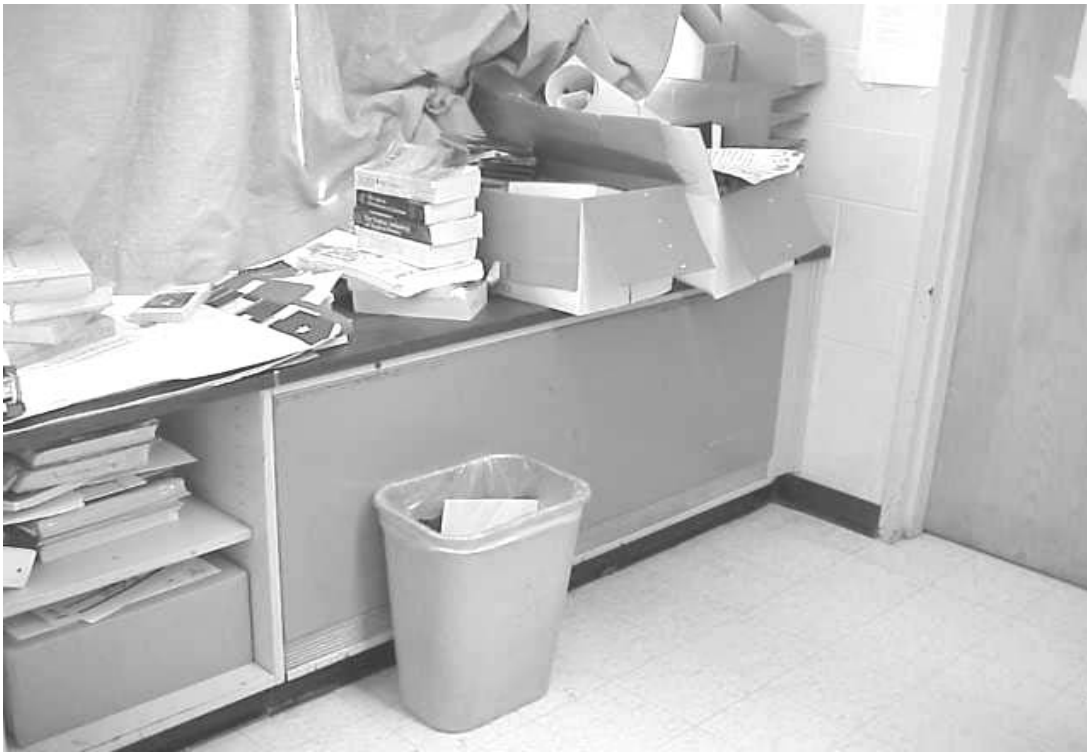
Picture 2

Fresh air in classrooms is supplied by a unit ventilator ([univent](#)) system (see Picture 2). Univents draw air from outdoors through a fresh air intake located on the exterior walls of the building (or in some cases on the roof (see Pictures 3 & 4)) and return air through an air intake located at the base of each unit (see Figure 2). Fresh air and return air are mixed, filtered, heated and provided to classrooms through a fresh air diffuser located in the top of the unit. Univents were deactivated in a number of classrooms surveyed (see Tables). Obstructions to airflow, such as books, papers and posters on top of univents, as well as bookcases, tables and desks in front of univent returns, were seen in a number of classrooms (see Pictures 2 & 5). To function as

Classroom Univent Note Materials on Air Diffuser Obstruction Airflow

3. Examine each univent for function. Survey classrooms for univent function to ascertain if an adequate air supply exists for each room. Consider consulting a heating, ventilation and air conditioning (HVAC) engineer concerning the calibration of univent fresh air control dampers building-wide.

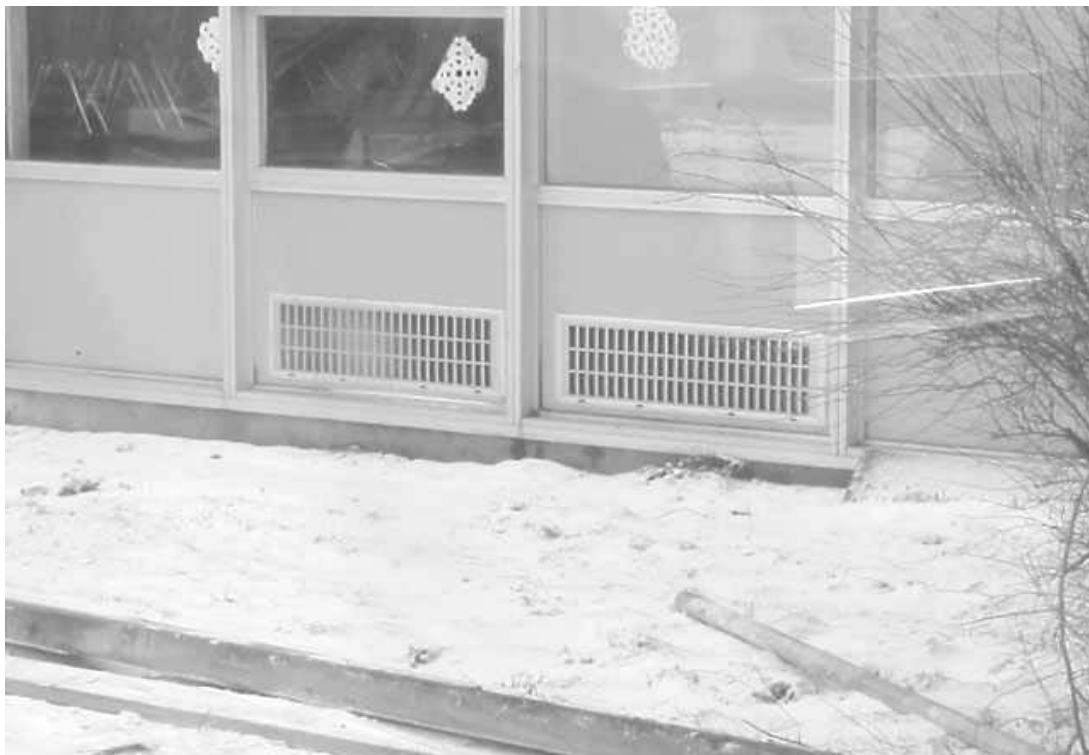
Picture 3

Univent Fresh Air Intake

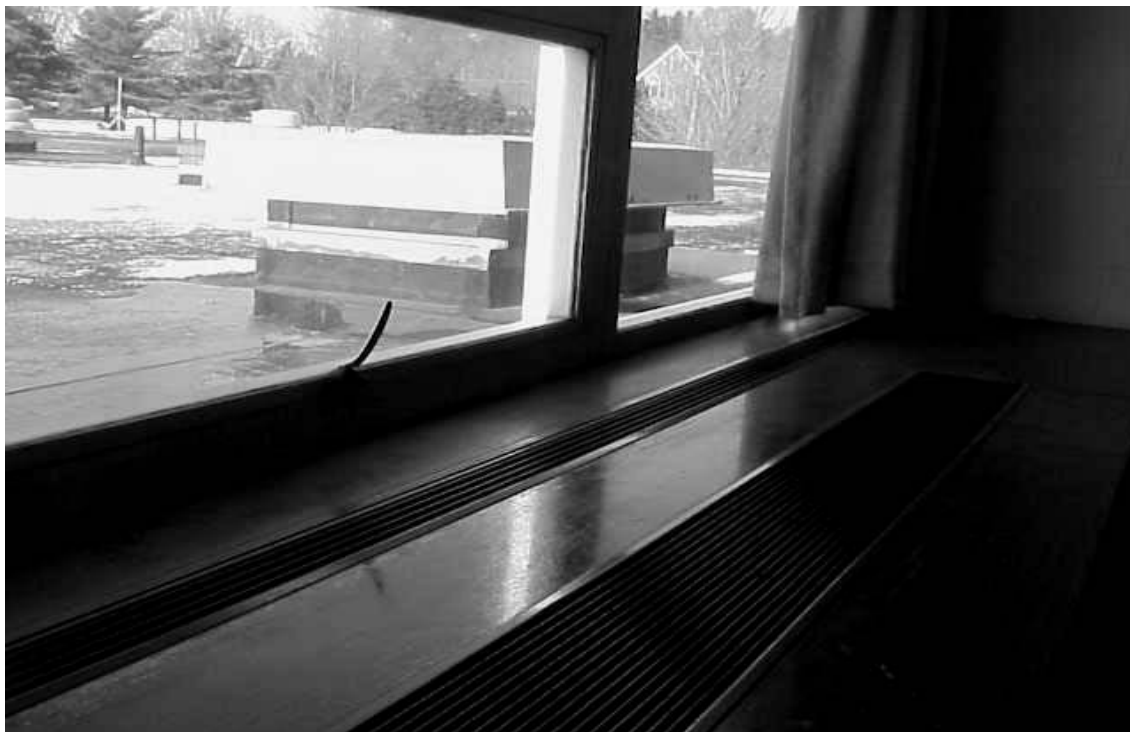
Picture 4

Univent Air Intake (Outside Window on Roof)

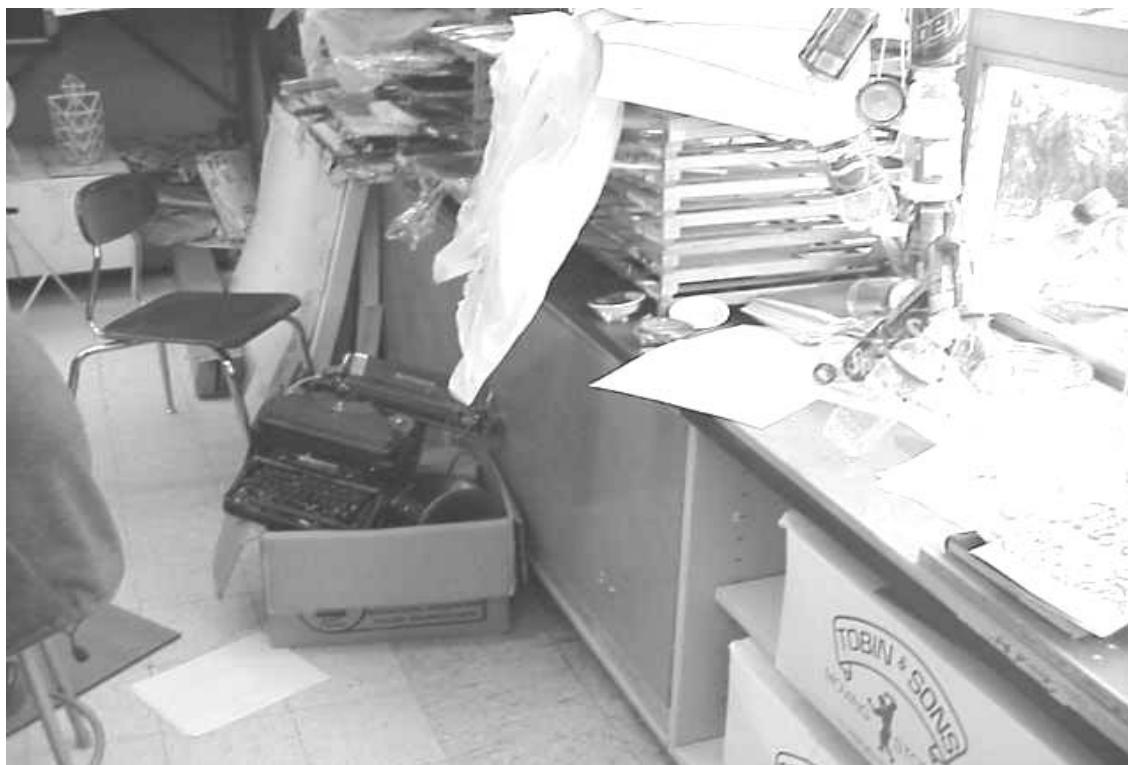
Picture 5

Univent Obstructed by Items on and in front of Unit

designed, univents and univent returns must remain free of obstructions. Importantly, these units must be activated and allowed to operate during hours of school occupation.

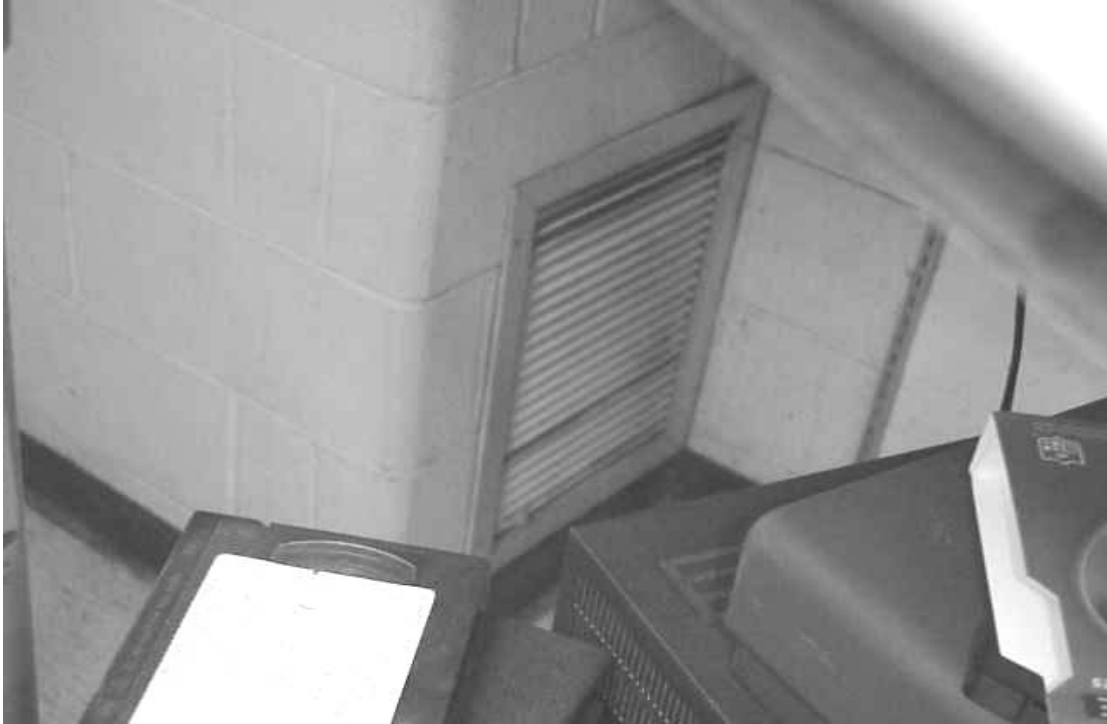
Picture 6

The mechanical exhaust ventilation system consists of either ceiling or wall-mounted exhaust vents (see Pictures 6 & 7) powered by rooftop motors or unit exhaust ventilators (see Picture 8) located along the exterior wall of the classroom. As with the univents, a number of exhaust vents were obstructed by tables, chairs, boxes and other items (see Picture 9). A number of unit exhaust ventilators were either off or drawing weakly. In addition several wall/ceiling vents were not operating, which can indicate that exhaust ventilation was turned off, or that rooftop motors were not functioning.

Wall-Mounted Exhaust Vent

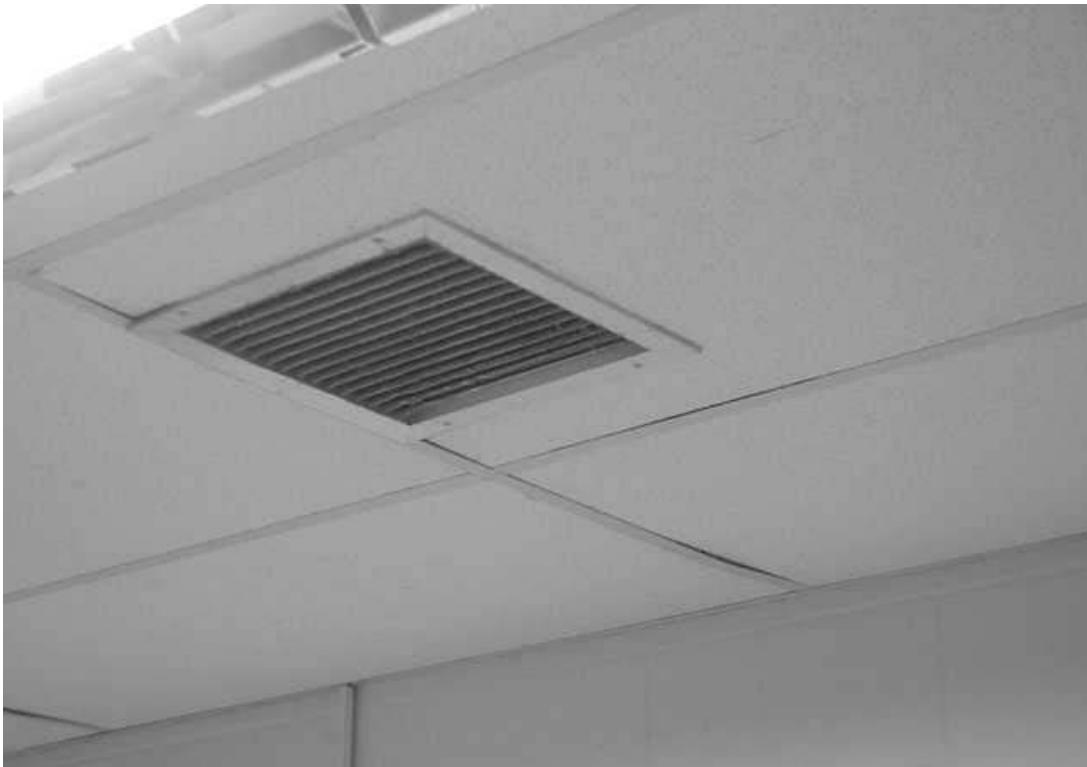
Picture 7

Classroom 100 contains a ceiling mounted exhaust vent but is not equipped with mechanical supply ventilation (shown in Picture 7). To introduce air into the room a passive vent was installed in the classroom door (see Picture 10). As air is drawn out of the room through the exhaust vent a negative pressure gradient is created, which facilitates the draw of air into the room through the passive vent. However, the exhaust vent was not operating, which rendered this system ineffective. Without removal by the exhaust ventilation, normally occurring environmental pollutants can build up (as evidenced by the elevated carbon dioxide levels) and lead to indoor air complaints.

Ceiling Mounted Exhaust Vent

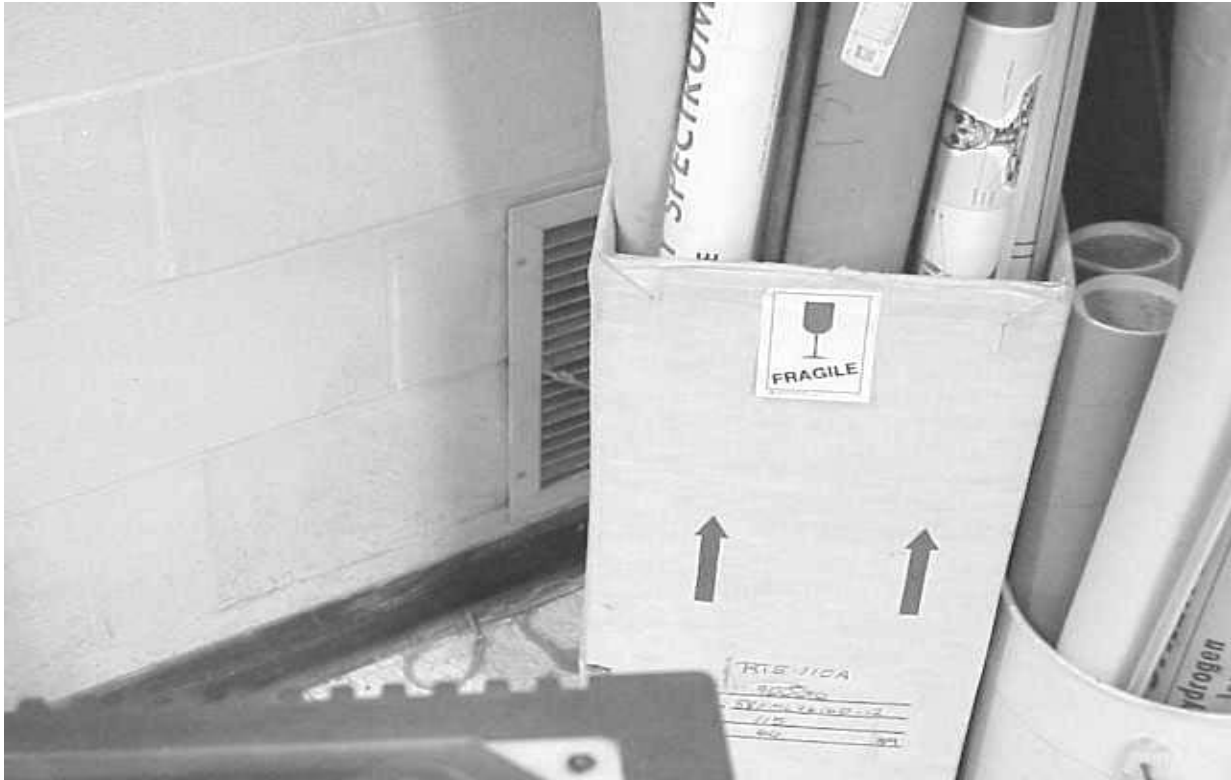
Picture 9

Exhaust Vent Blocked by Boxes

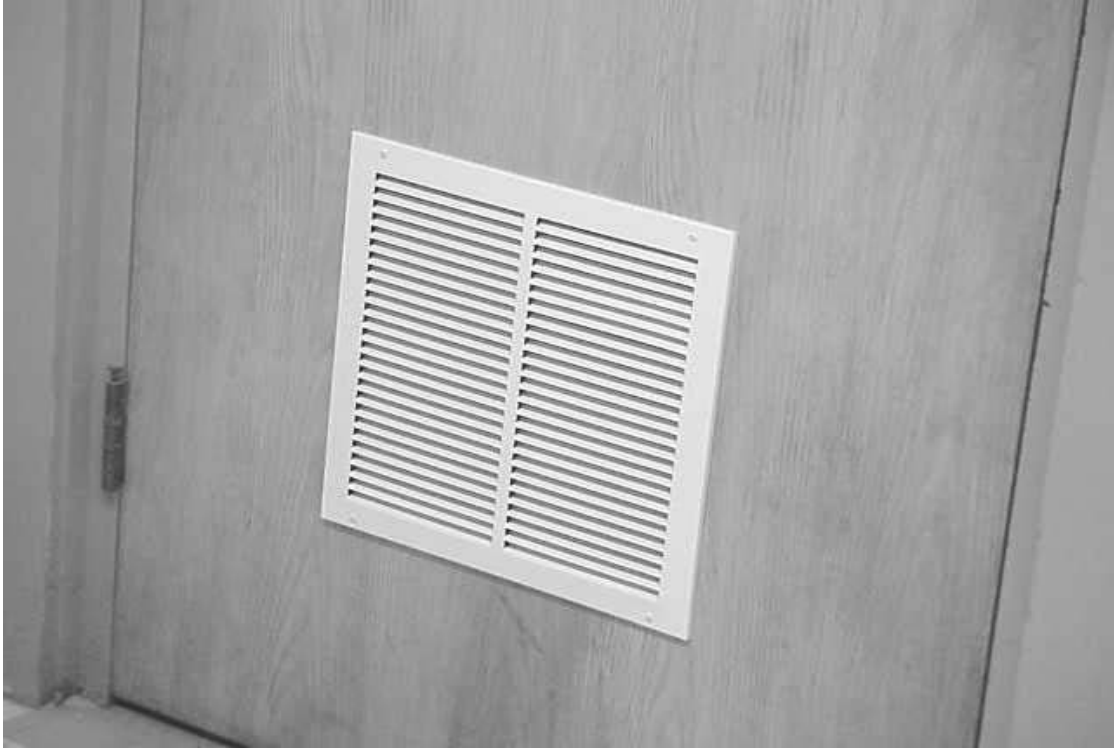
Picture 10

Passive Vent Installed in Classroom 100

1. Inspect roof for proper drainage and make repairs as needed, examine periodically for standing water.
2. Repair/replace broken and/or loose windows and replace missing or damaged window caulking to prevent water penetration through window frames.
3. Consider the installation of mechanical supply ventilation to classroom 100.

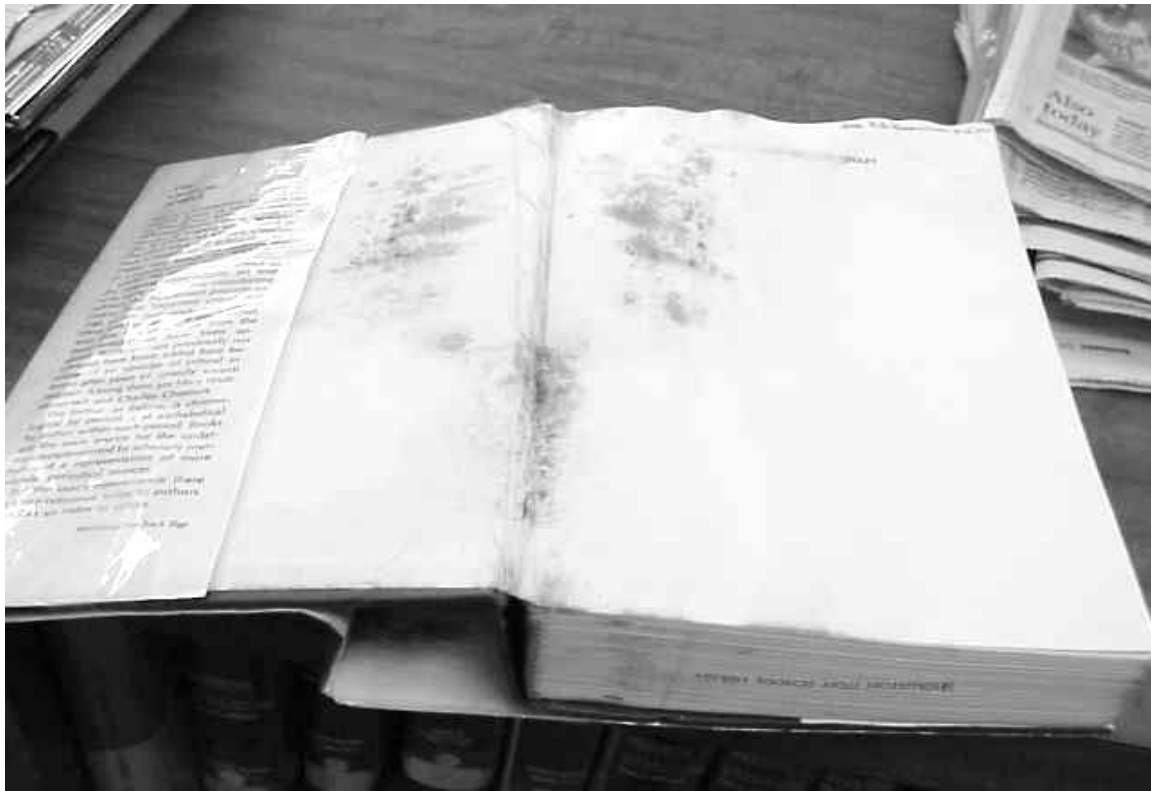
Picture 11

A musty/moldy odor was detected in the library. BEHA staff identified a water damaged book on a shelving unit as the most likely source of these odors. The book was colonized with mold growth (see Picture 11). Some individuals can be sensitive to mold, which can result in irritation of the eyes, nose, throat or respiratory system. BEHA staff informed the librarian and recommended that the book be discarded.

Water Damaged Book in Library, Dark Spots Indicate Mold Growth

6. Remove moldy materials from the library and clean nonporous surfaces with an appropriate antimicrobial agent; wipe down afterwards with soap and water.

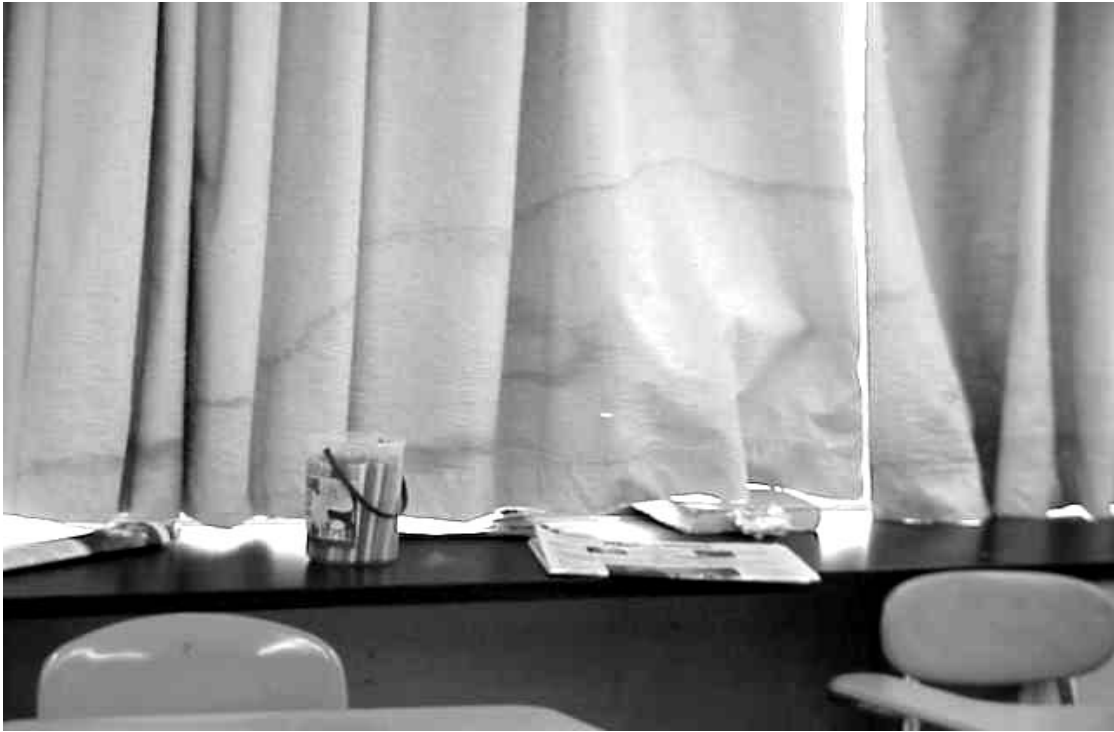
Picture 12

Throughout the school, caulking around the interior and exterior windowpanes was crumbling, missing or damaged. Water damaged curtains were noted in Picture 12. Once mold has colonized, porous materials should be replaced, as they are difficult to clean. Repairs of window leaks are necessary to prevent further water penetration.

Water Damaged Curtains in Classroom

9. Replace water damaged/deteriorating curtains in classrooms.
10. Properly store chemicals and cleaning products. Have a chemical inventory done in all storage areas and classrooms. Discard hazardous materials or empty containers of hazardous materials in a manner consistent with environmental statutes and regulations. Follow proper procedures for storing and securing hazardous materials. Obtain Material Safety Data Sheets (MSDS') for chemicals from manufacturers or suppliers.

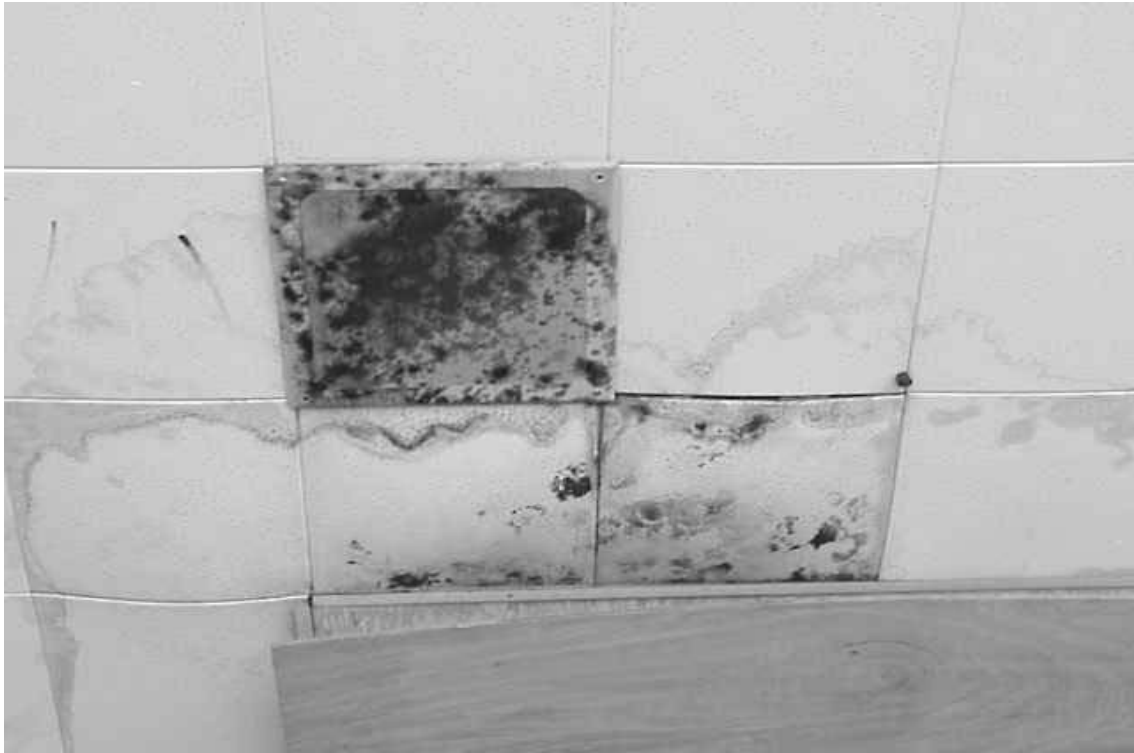
Picture 14

Stained ceiling tiles were observed in some areas (see Picture 14). Water-damaged ceiling tiles can provide a source of mold and mildew and should be replaced after a water leak is discovered. A few areas had plants (see Picture 15). Plant soil and drip pans can serve as source of mold growth. Plants should be properly maintained and be equipped with drip pans. Plants should also be located away from the air stream of mechanical ventilation to prevent aerosolization of dirt, pollen or mold.

Water Damaged Ceiling Tiles Dark Spots Indicate Potential Mold Growth

8. Replace any remaining water-stained ceiling tiles, wall board and pipe insulation. Examine the areas above and around these areas for mold growth. Repair water leaks and disinfect areas of water leakage with an appropriate antimicrobial if necessary.

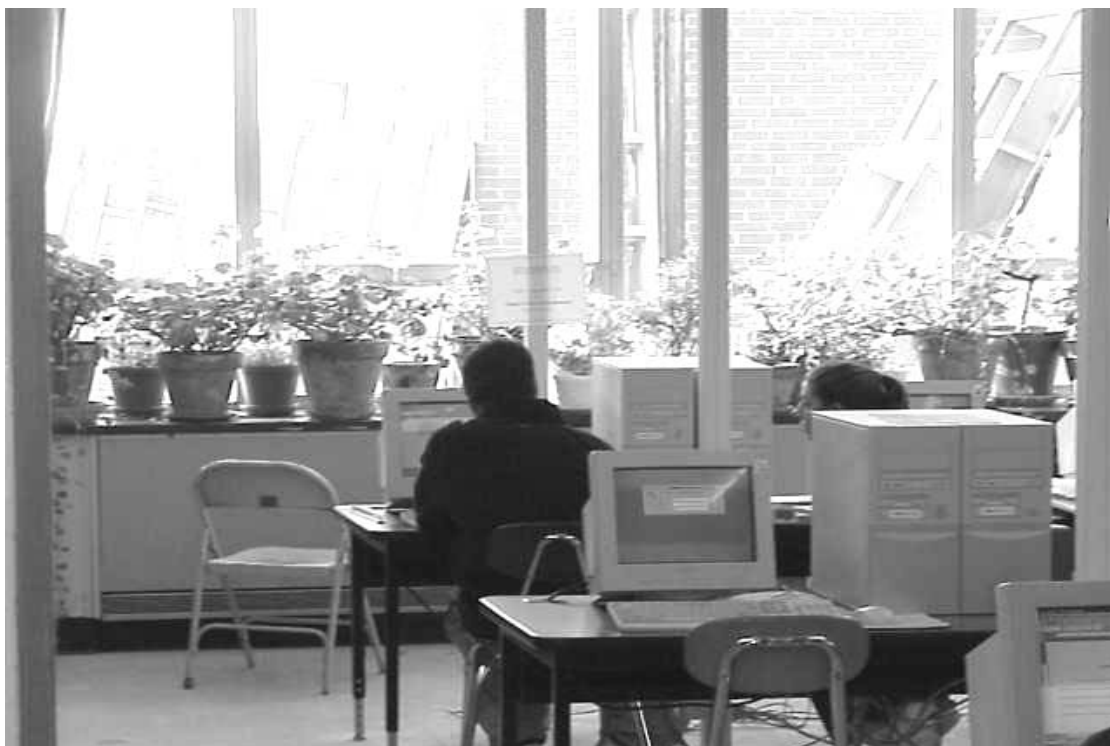
Picture 15

Flowering Plants on top of Univents

7. Keep plants away from univents in classrooms. Ensure plants have drip pans, examine drip pans for mold growth and disinfect areas with an appropriate antimicrobial where necessary.

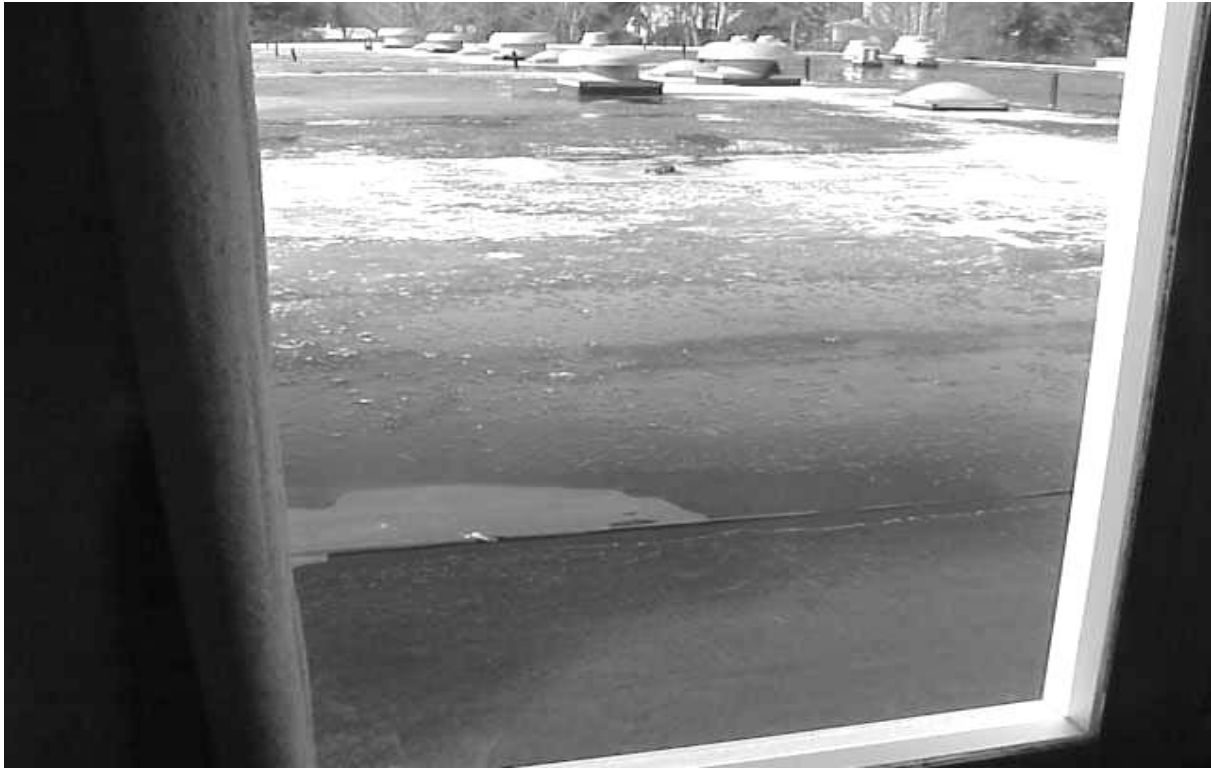
Picture 16

Pooling water was observed in a number of areas on the roof (see Picture 16). The freezing and thawing of water during winter months can lead to roof leaks and subsequent water penetration into the interior of the building. Pooling water can also become stagnant, which can lead to mold and bacterial growth, which can be introduced into the building by rooftop fresh air intakes. In addition, stagnant pools of water can serve as a breeding ground for mosquitoes in warmer months.

Pooling Water and Ice on Rooftop

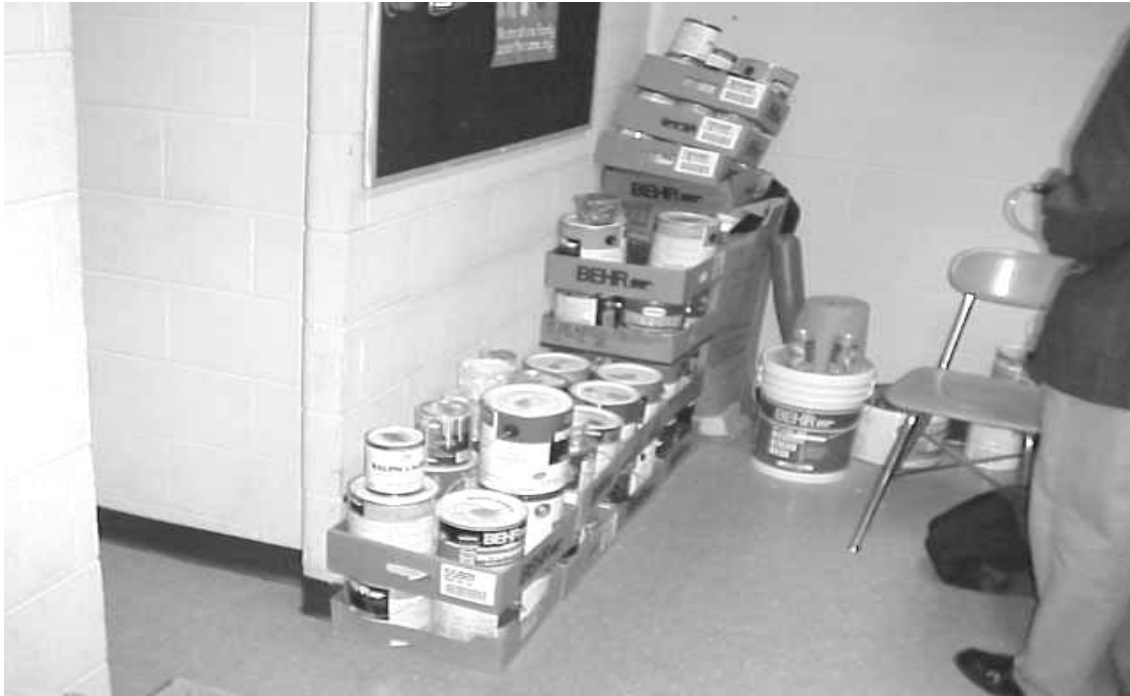
Picture 17

Several other conditions were noted during the assessment, which can affect indoor air quality. A number of containers including paint, waterproofing materials and other items were being stored on the floor in the storeroom off of class 151 (see Picture 17). These products contain VOCs, which readily evaporate and can be irritating to eyes, nose and throat. Some of these products are flammable as well, and should be stored in a cabinet which meets the criteria set forth by the National Fire Protection Association (NFPA) (NFPA, 1996).

Paints, Waterproofing and Other Materials Stored in Room 151 Storeroom

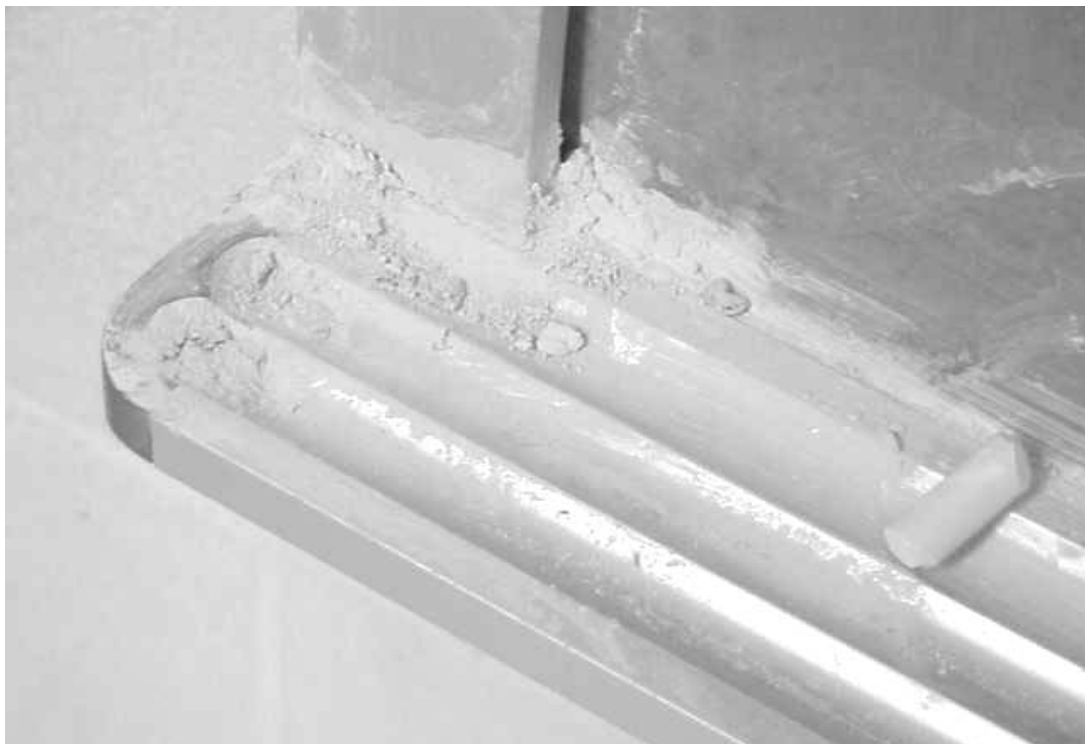
Picture 18

Accumulated chalk dust was noted in several classrooms (see Picture 18). Chalk dust is a fine particulate, which can become easily aerosolized and serve as a source of eye and respiratory irritation. A number of classrooms contained dry erase boards and dry erase board markers. Materials such as dry erase markers and dry erase board cleaners may contain volatile organic compounds (VOCs), (e.g. methyl isobutyl ketone, n-butyl acetate and butyl-cellusolve) (Sanford, 1999), which can also be irritating to sensitive individuals.

Accumulated Chalk Dust in Classroom

13. Clean chalk boards and chalk trays regularly to prevent the build-up of excessive chalk dust.
14. Clean/change filters in window-mounted air conditioners as per the manufacturer's instructions to prevent the re-aerosolization of dirt, dust and particulate matter.

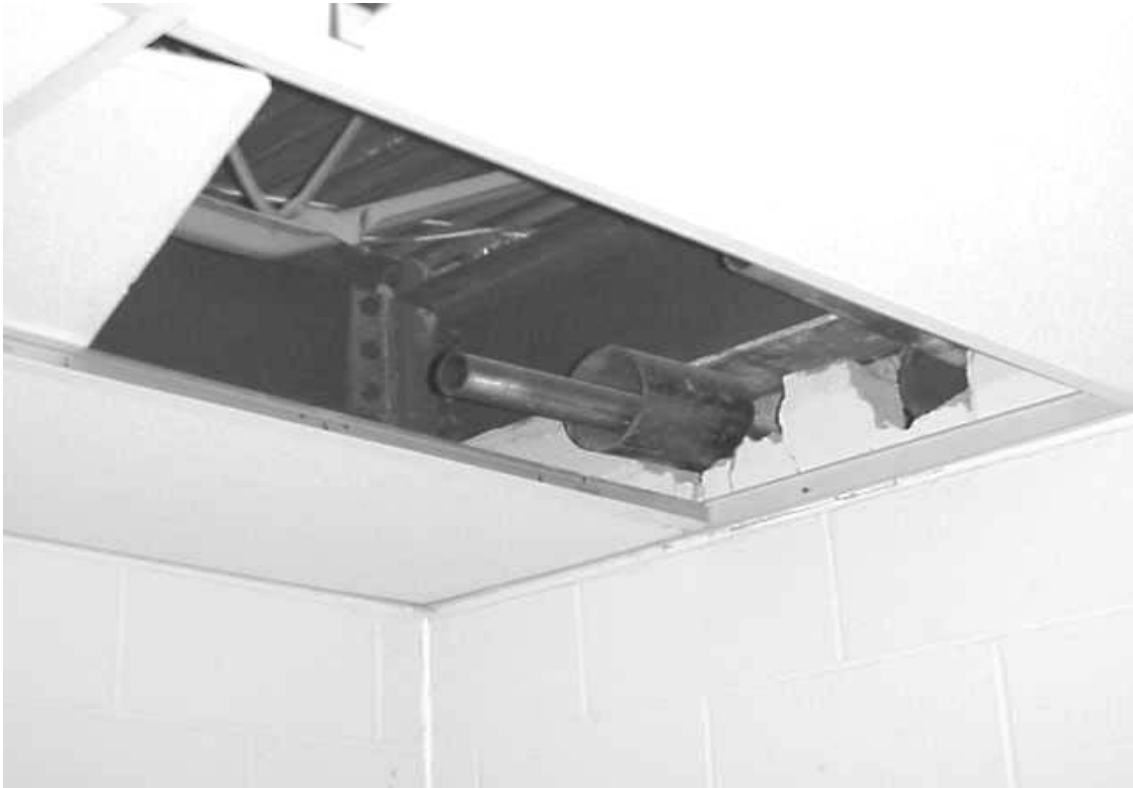
Picture 19

Several areas had missing/dislodged ceiling tiles (Picture 19). Missing ceiling tiles can provide a means of egress for odors, fumes, dusts and vapors between rooms and

Missing Ceiling Tiles

12. Seal utility holes and replace missing ceiling tiles to prevent egress of odors, fumes and vapors between rooms and floors.

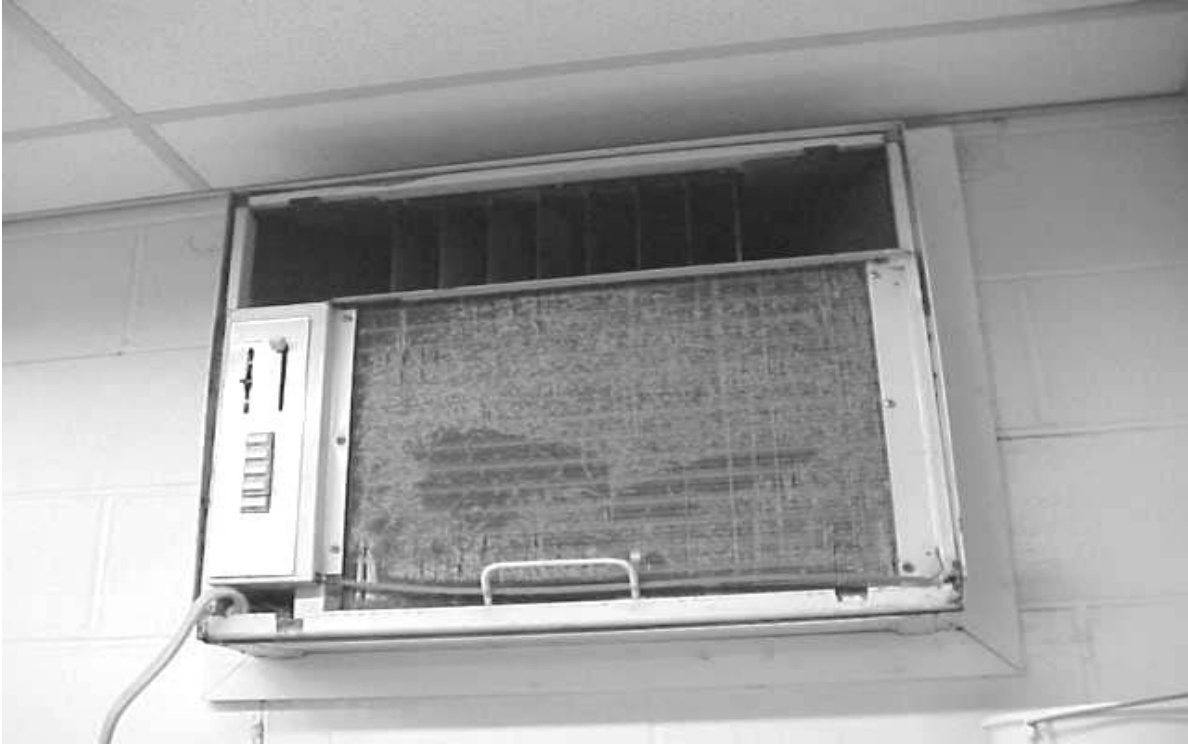
Picture 20

floors. Window-mounted air conditioners without covers were noted in rooms 100 & 203. The inside grills of the units were coated with dirt/dust (see Picture 20). The activation of this unit or the movement of ceiling tiles can introduce dirt, dust and particulate matter into occupied areas of the school. These materials can be irritating to certain individuals. In addition, air conditioners are normally equipped with filters, which should be cleaned or changed as per the manufacturer's instructions to avoid the build up and re-aerosolization of dirt, dust and particulate matter.

Dirt/dust Accumulation in Grill of Portable Classroom AC

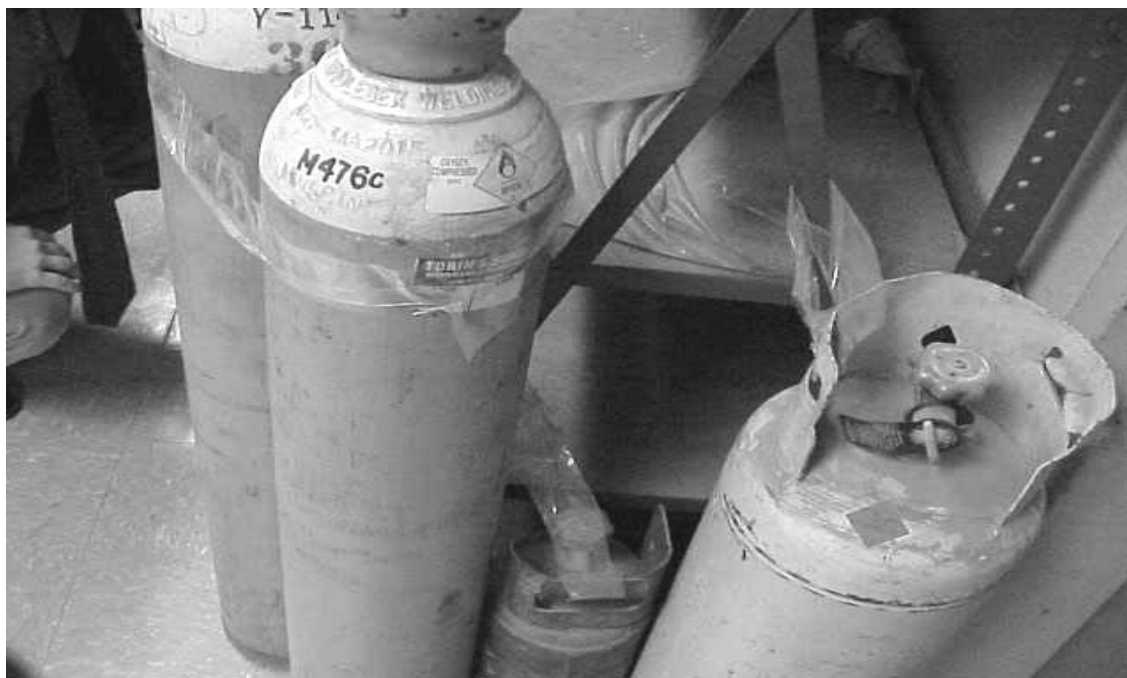
Picture 21

- Bases were being stored in an acid storage cabinet along with acids. Bases and acids should not be stored together.
- Gas cylinders were stored in an upright position secured with clear packing tape (see Pictures 21 & 22). Cylinders of compressed gas should be fixed to a wall or stand to prevent damage to the cylinder valves by tipping. A damaged cylinder valve can cause an immediate and uncontrolled release of the cylinder contents and may result in the cylinder becoming a projectile.

Gas Cylinders in Chemical Storeroom Secured with Tape

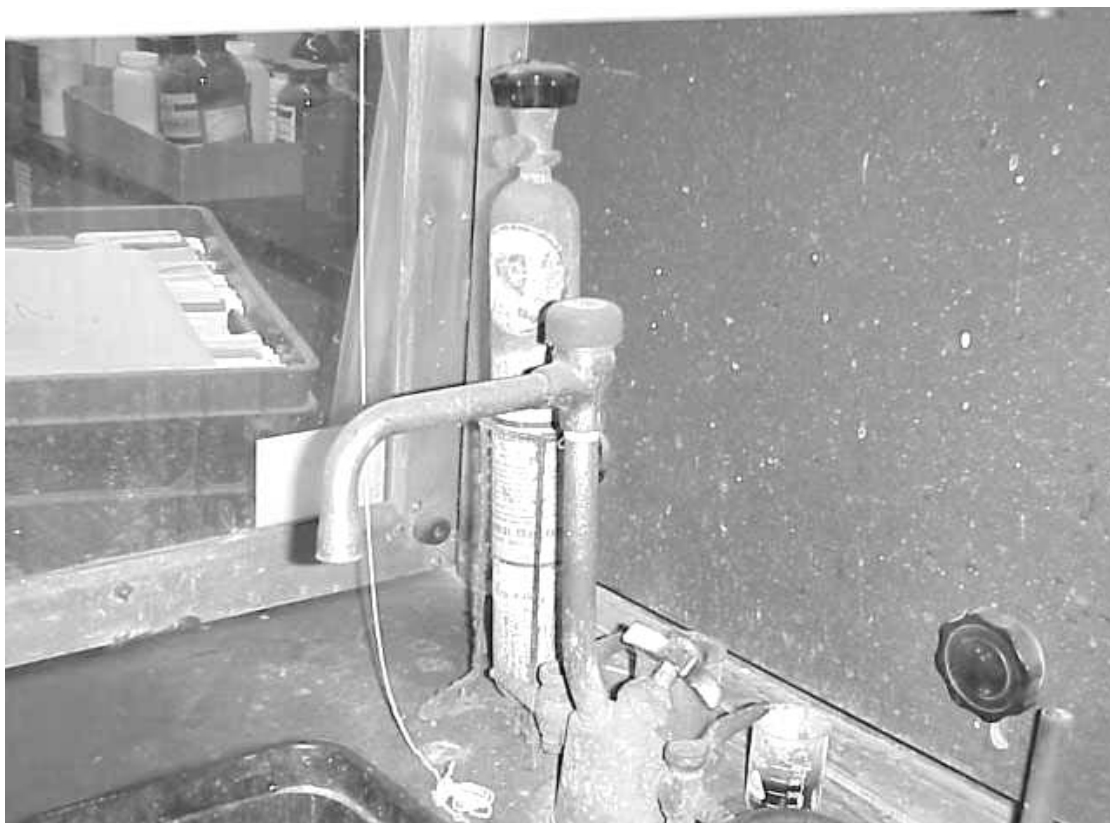
Picture 23

- A number of materials appear to be of extreme age.
- Some containers were sealed with glass stoppers.
- Science classrooms contained inoperative ventilation hoods. Stored in these vent hoods were a number of different chemicals including a gas cylinder of chlorine (see Picture 23). Metal fixtures within the vent hood are corroded, which indicates that chemical vapors have escaped from the chemical hood at some previous date to corrode the exterior of this equipment. The purpose of chemical

hoods is to draw aerosolized chemical vapors and odors from the work area out of the building. Chemical hoods should not be used for storage of unattended materials because this equipment can be deactivated during off-hours (Rose, S. L., 1984). If the chemical hood is deactivated, off-gassing material can penetrate into adjacent areas. Chemical hoods should be on at all times that chemicals are within the equipment. It is also good chemical hygiene practice to return stock bottles back to the storage cabinet after use.

**Chlorine Gas Cylinder Located in Inoperable Vent Hood
Note Corrosion of Metal Fixtures**

It is recommended that an ongoing, periodic inventory of chemicals in the science department be done to assess chemical storage and dispose of unwanted chemicals. Disposal of unwanted chemicals in a manner consistent with Massachusetts hazardous waste laws is recommended.
